Periodic Inspection of Jetties at Manasquan Inlet, New Jersey

Armor Unit Monitoring for Period 1994-1998

*by Robert R. Bottin, Jr., WES
William F. Rothert, Philadelphia District*

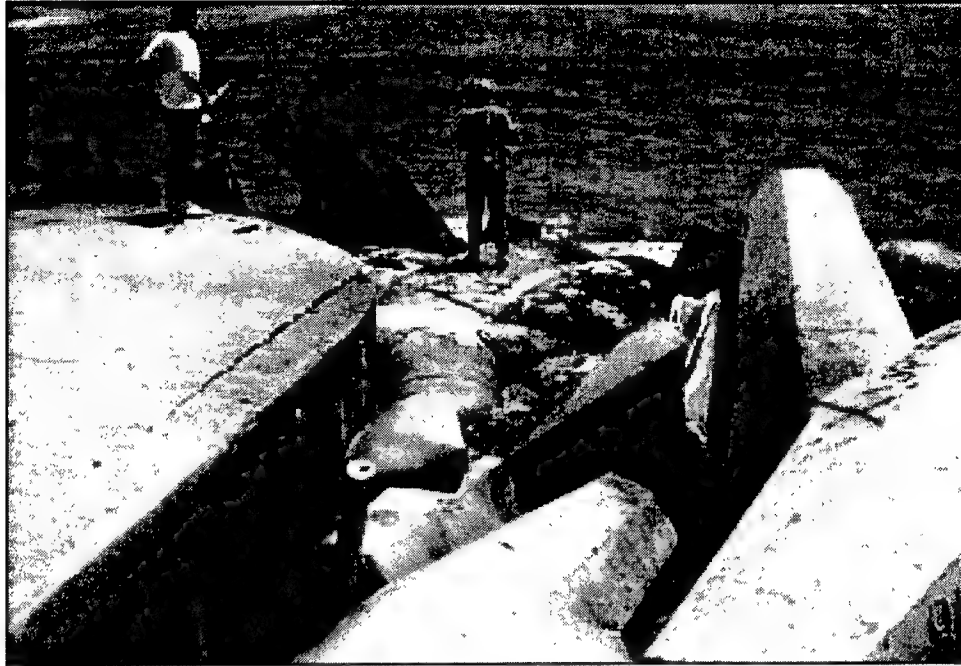
In 1995, maintenance was performed at the tip of the south jetty where core stone under the jetty cap was exposed. Nylon bags were placed in this area, and concrete was pumped into them as a temporary solution (Figure 9). A total of 53.5 cu m (70 cu yd) of concrete was used. This was the first maintenance performed on the jetties since the major rehabilitation was completed in 1982.

Figure 9. Emergency repair work (grout-filled bags) at head of south jetty (performed in 1995)

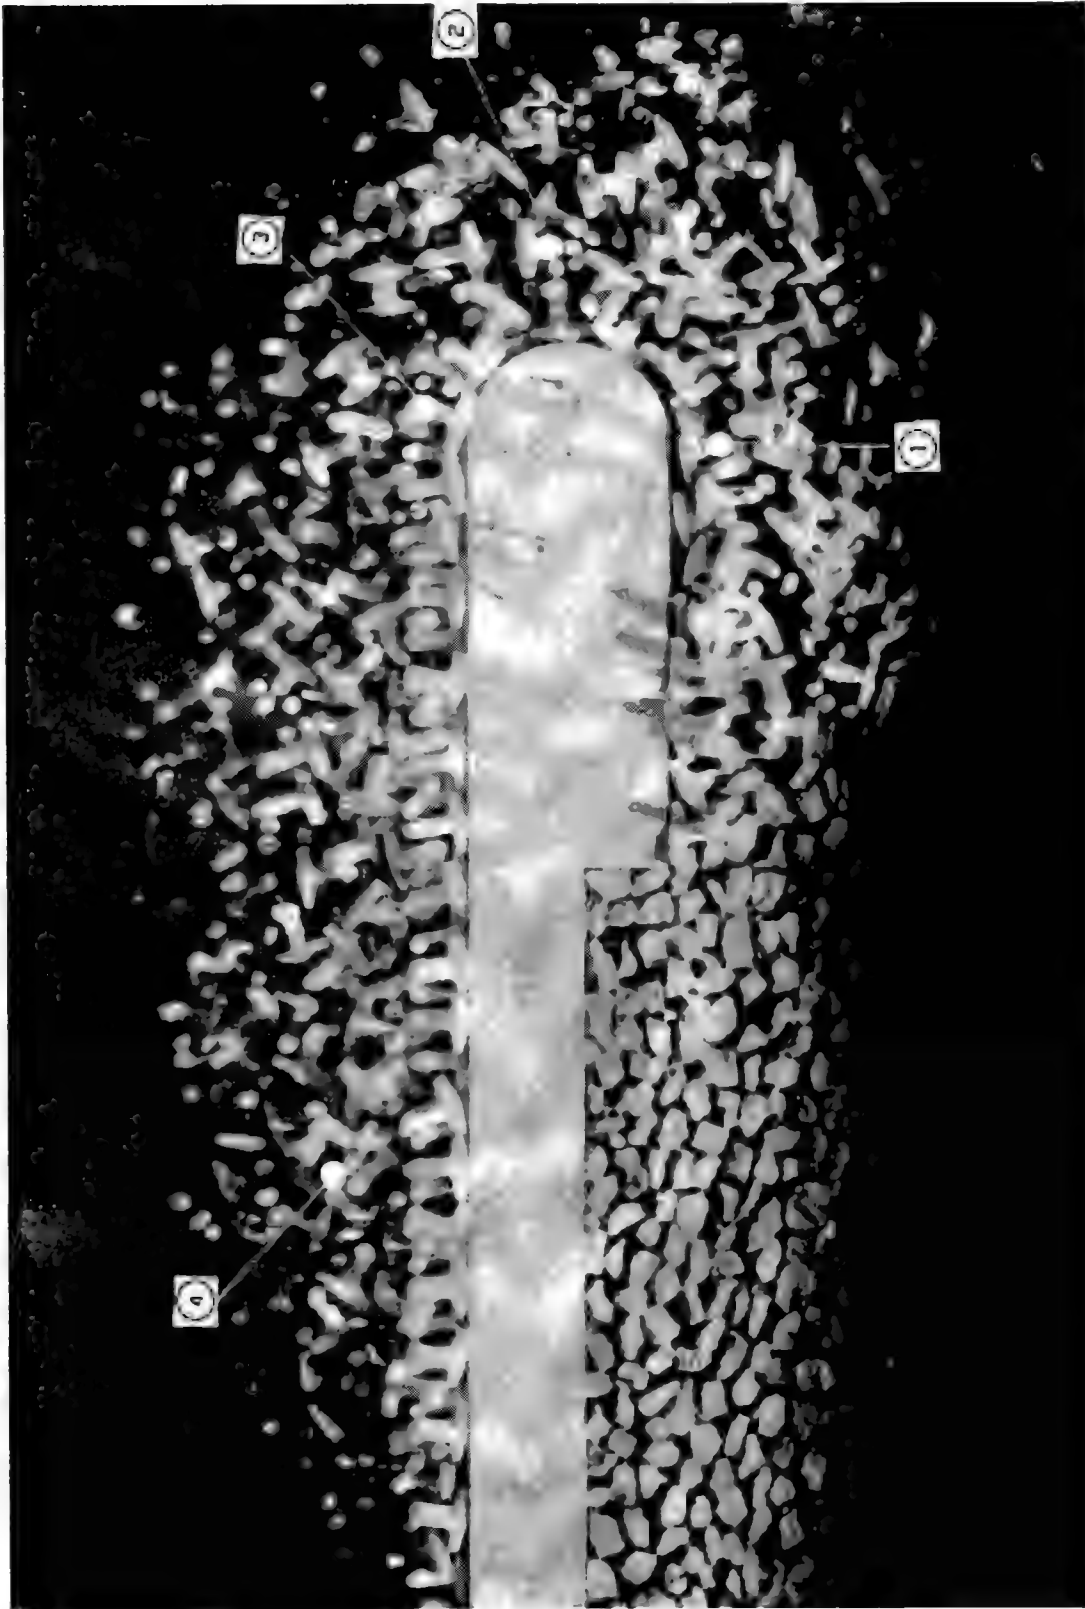
locations are shown in Figures 23 and 24. Some of the data recorded relative to these broken/cracked dolos armor units are shown in Table 4. Of the eight broken/cracked dolos armor units observed, six were identified in the previous (1994) survey, and two (units 1 and 4 on the north jetty) were new breaks.

Figure 23. Approximate locations of broken/cracked dolos armor units on north jetty

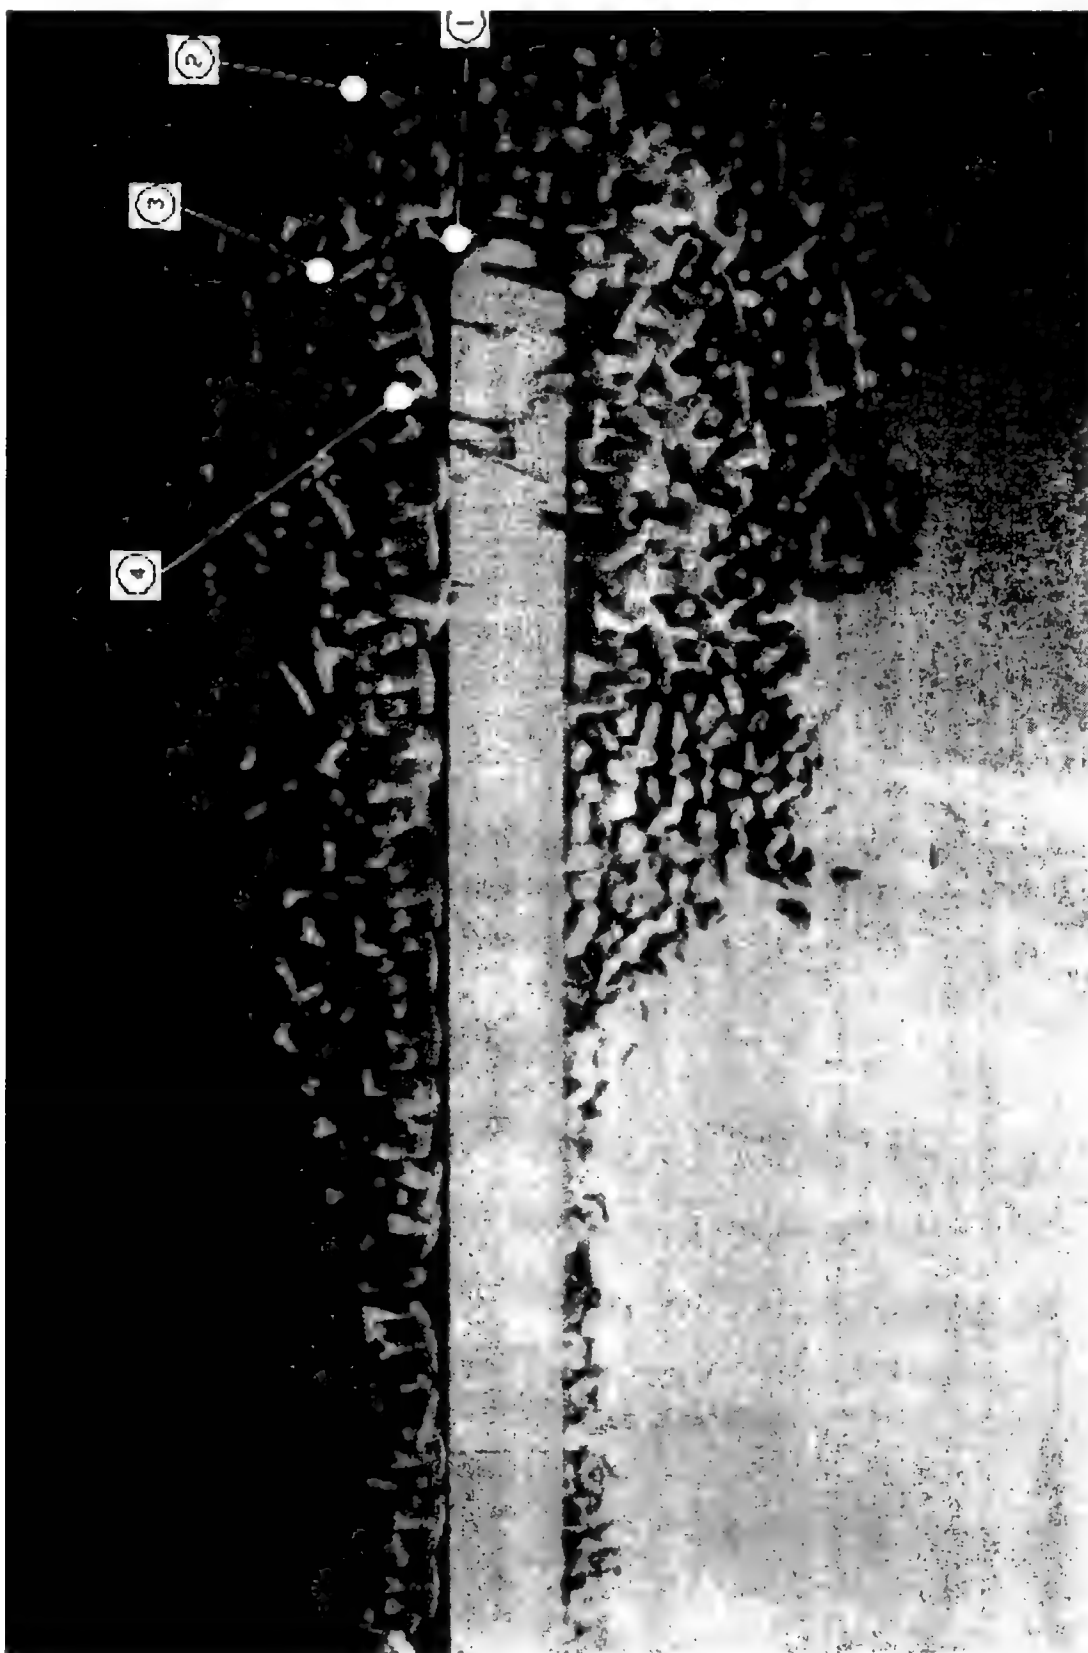
Figure 24. Approximate locations of broken/cracked dolos armor units on south jetty

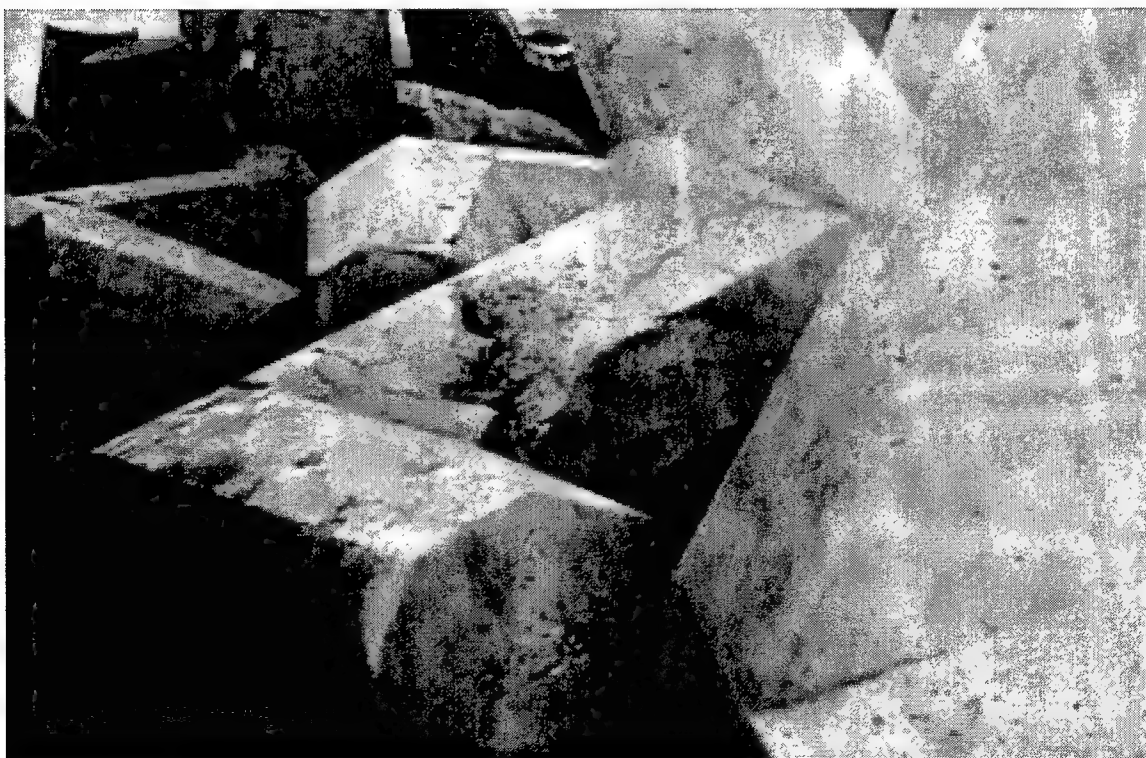
Considering the types of breaks, the majority (six) were shank-fluke breaks. There was one midshank break and one fluke-shank break. There were four angled breaks and four straight ones. Comparison of breakage to production data showed that no production group had an unusual amount of breakage. The distribution of broken/cracked dolosse indicated that seven of the eight units were concentrated around the seaward heads of the jetties, as shown in Figures 23 and 24. Views of typical broken/cracked dolos armor units on the Manasquan Inlet

Figure 25. Dolos with angled midshank break

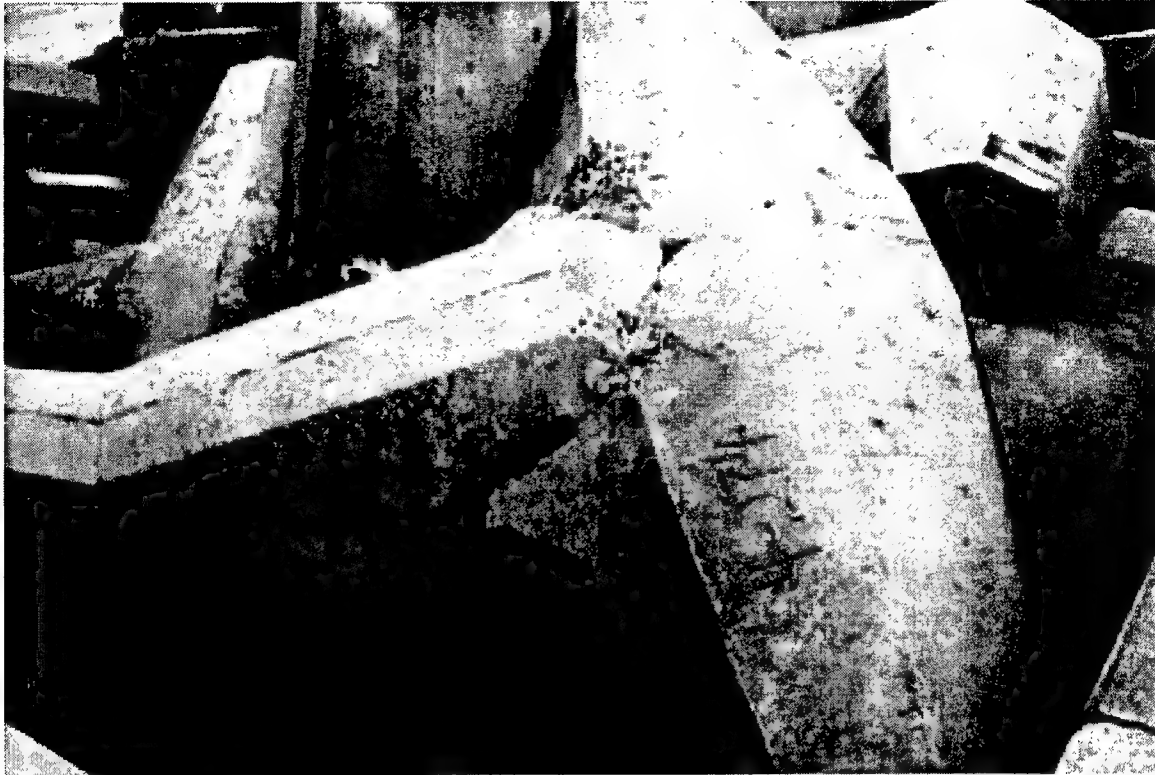
Figure 26. Dolos with angled shank-fluke break

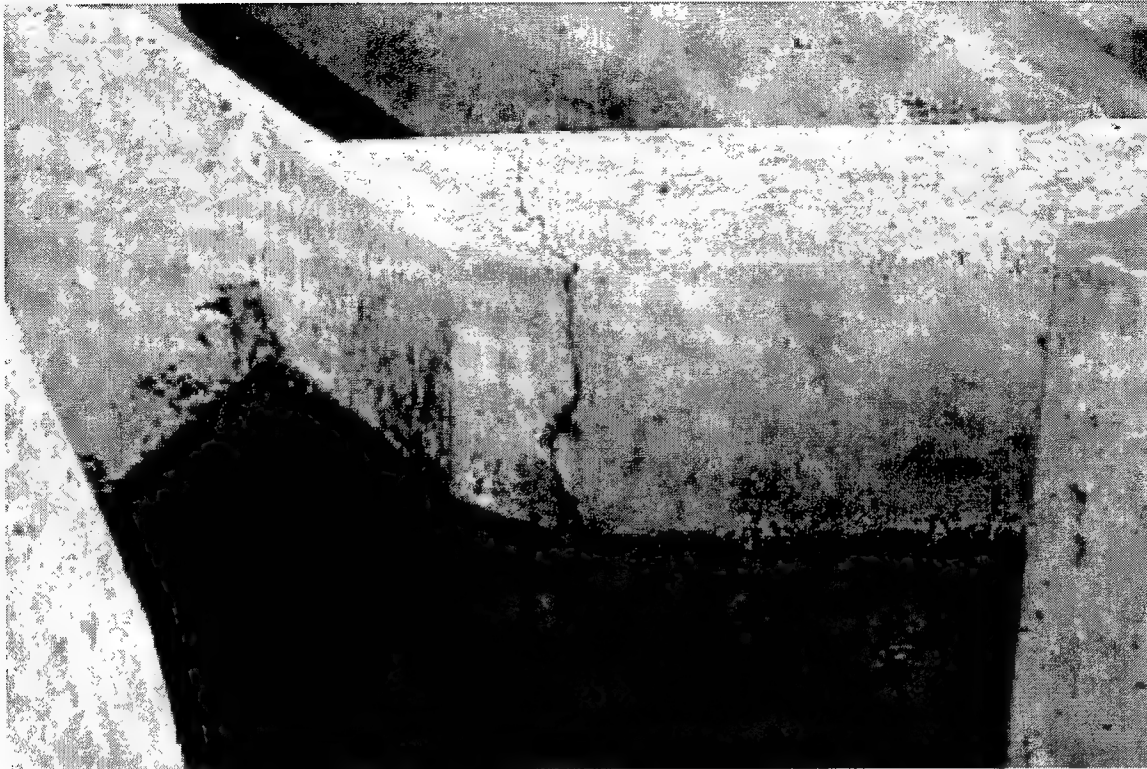
Figure 27. Dolos with straight shank-fluke crack
